RESEARCH BULLETIN

No. 125

Archaeological Investigations at Upper Fort Garry, 1978

Peter J. Priess, Archaeological Research, Parks Canada, Winnipeg

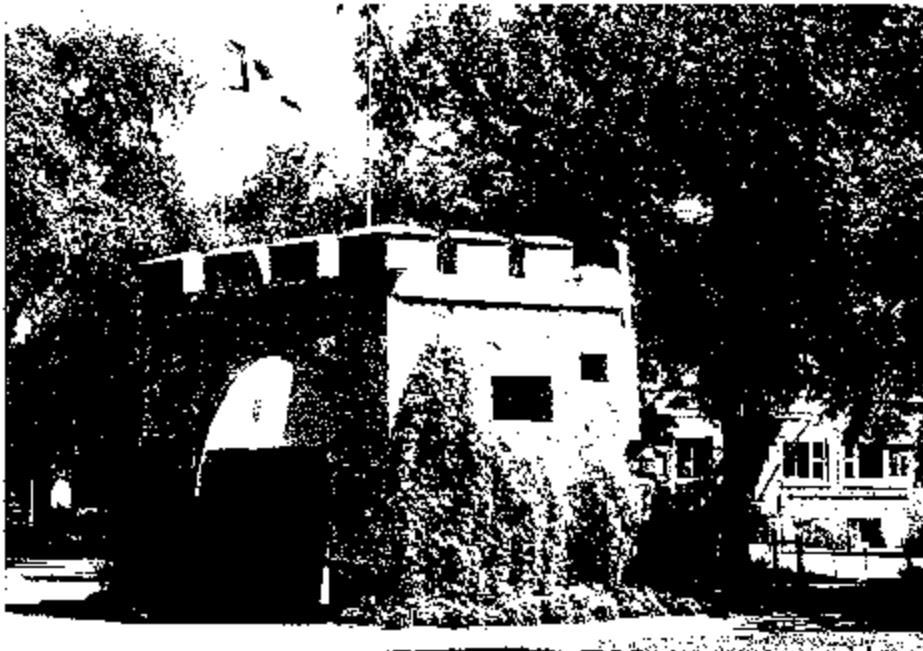
As it now stands the gate consists of two mortared limestone walls, oriented at a slight angle to each other and approximately perpendicular to the line of the north palisade of the fort (Figs. 1, 2). At the front of the gate (side facing away from the interior of the fort) these two walls are joined by a stone arch (Fig. 1); at the back (side facing interior of fort) the walls are not joined (Fig. 2). The overall plan of the gate is that of a trapezoid. The walls are two storeys in height, castellated and with a number of gun ports and other, larger openings at the second storey level. The second storey has a wooden floor and the back of the gate is closed from the second floor to the top of the walls with a wooden wall. These wooden elements are presumed not to be original and are to some extent in bad repair. The ends of the floor beams, resting on a ledge in the wall, are deteriorated and the floor is now supported by

1 General view of gate from fort exterior.

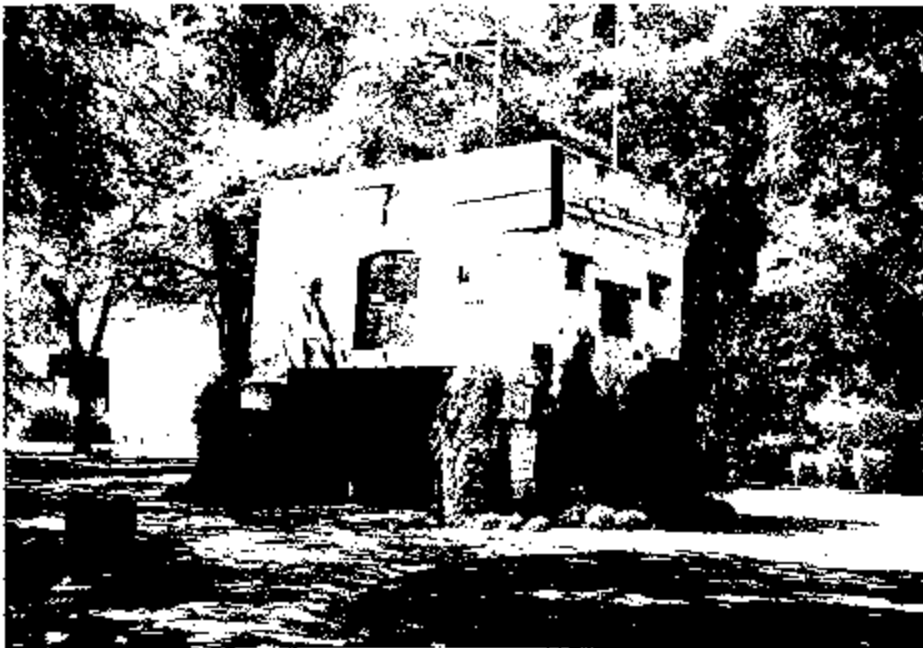
2 General view of gate from fort interior.

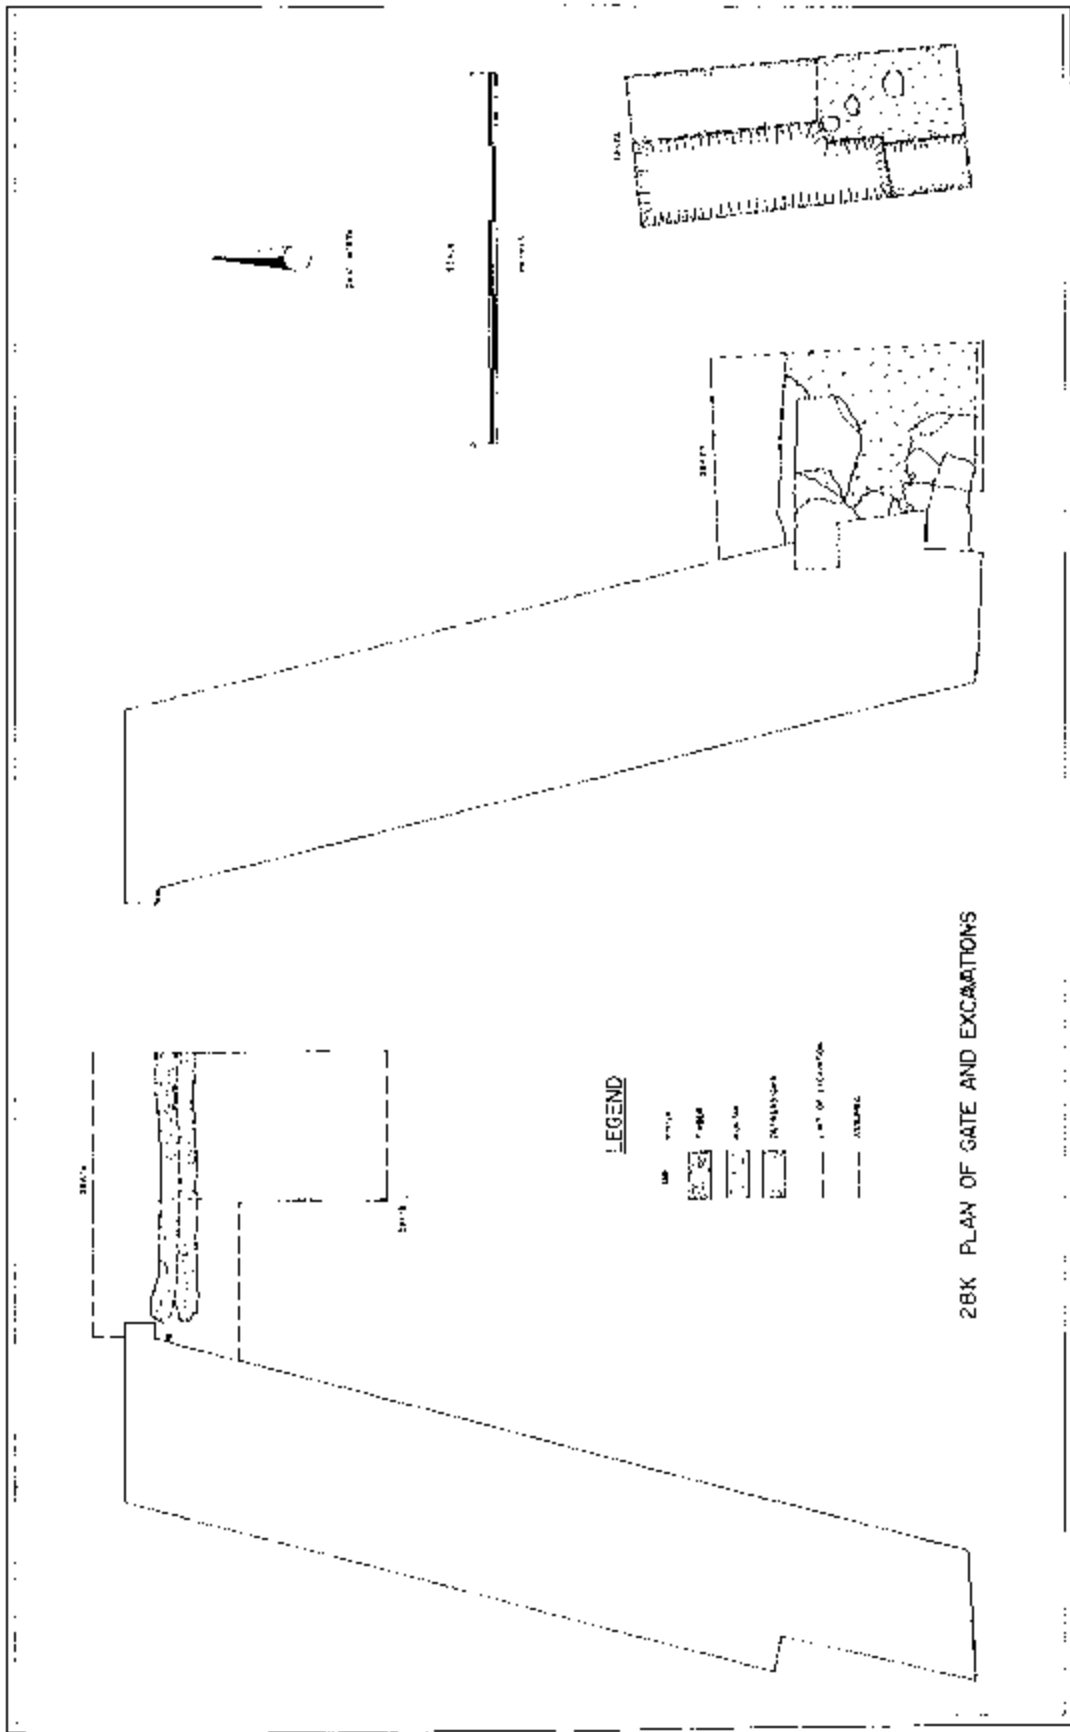
Much of the excavation unit was taken up by a footing of mortared limestone, layer 15 (Figs. 3, 15, 19) beginning at the gate wall and extending beyond the east side of the excavation (Figs. 3, 16). Between the top of the footing and the flower bed there was a layer of mottled clay, considered to be layer 3 (Fig. 16). This again provided proof that layer 3 post dates the occupation period, being deposited after removal of the palisade. The top of the footing was irregular, the top stones having been removed. Only at the wall was the footing likely at an original level; the top of the footing there was level with the bottom of the slot in the wall (Fig. 19). The top of the footing did not retain any features to indicate the manner of wall construction. In width the footing extended to the outside edges of the slots in the gate wall (Figs. 3, 19).

3 Outline of gate, location of excavations and plan view of excavated features (Draftsperson: K. Walton).

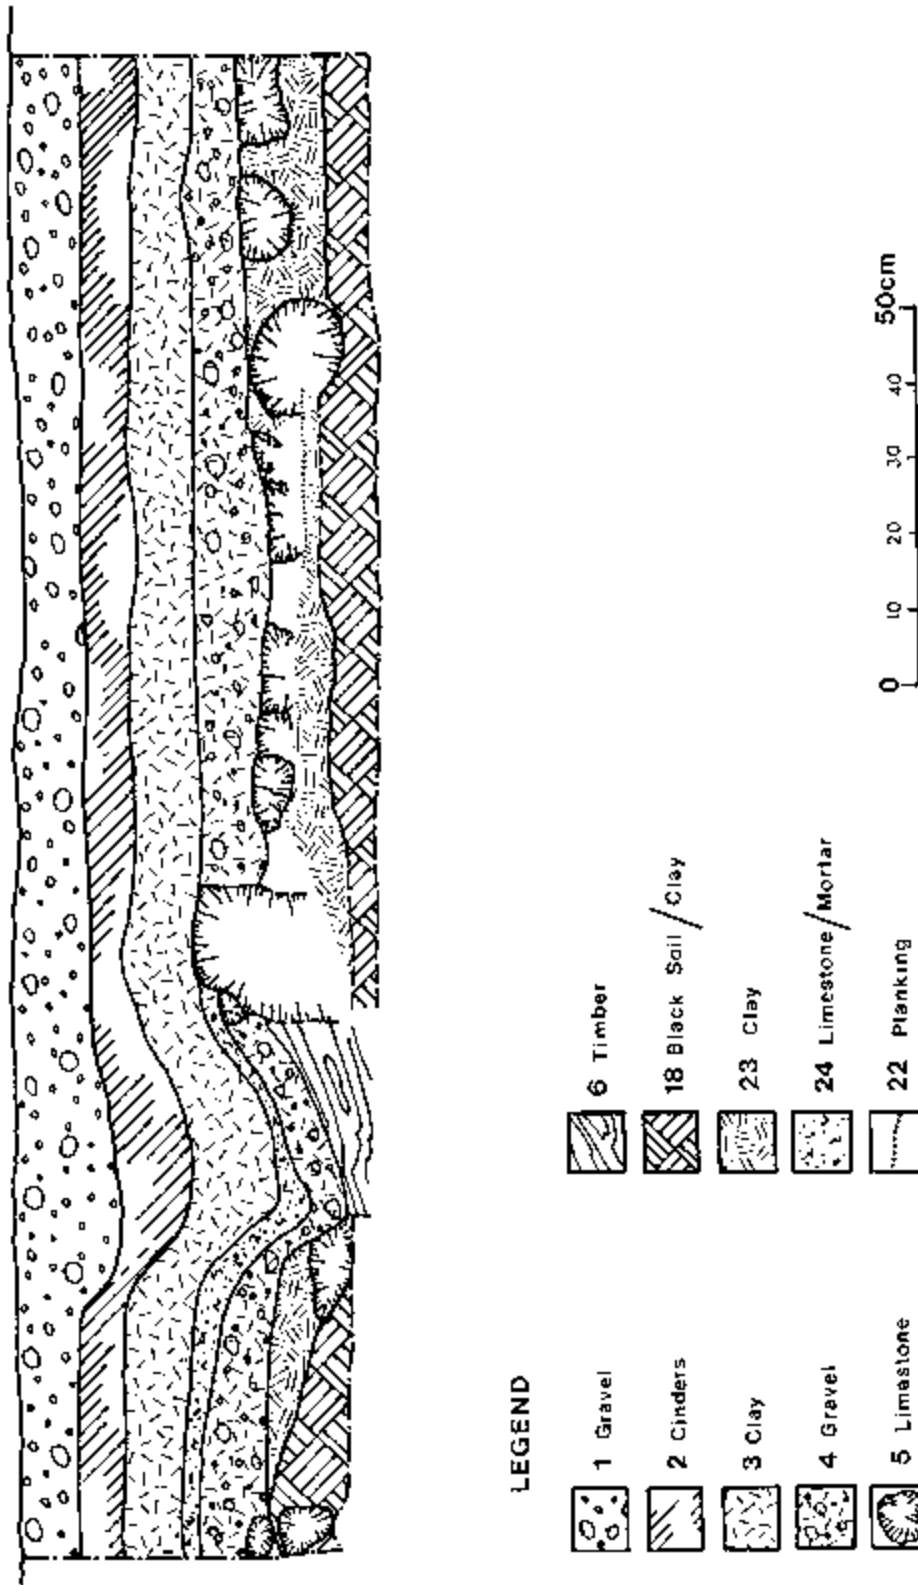
Layer 1 (Figs. 9, 10) was a fine, sandy rounded gravel comprising the present surface of the path and an unknown number of past surfaces. This layer has probably been built up over the years as a result of efforts to maintain the appearance of the path and the park; as the surface of the path collected dirt, beginning to appear less attractive and less suitable for pedestrians, it was covered by another thin layer of clean gravel. Beyond the limits of the excavation, the path is now bordered by a flower bed (Fig. 5). The artifacts present are primarily recent, of the 20th century and occasionally dating within the last fifty years. Included are a fragment of soft drink bottle which, on the basis of its method of labelling, is dateable to post ca. 1930 (K. Lunn, personal communication) and another fragment of glass container marked 1936, possibly indicative of a date. Also included was a fragment of barbed wire and a wire fencing staple. The crown closure cap present is a type of cap patented in 1892 (Lief 1965: 17).

In the northeast corner of the excavation there is a thin layer of mortar and limestone chips, layer 24, between layers 3 and 4 (Figs. 9, 10). To the south it overlies the sill but does not extend beyond it (Fig. 9). It is most likely construction debris resulting from repairs and deposited during the occupation period or even later. Its presence above layer 4 provides a stronger suggestion for layer 4 being an occupation period deposit.

9 East profile of 28K-1A. (Drafting by K. Walton).

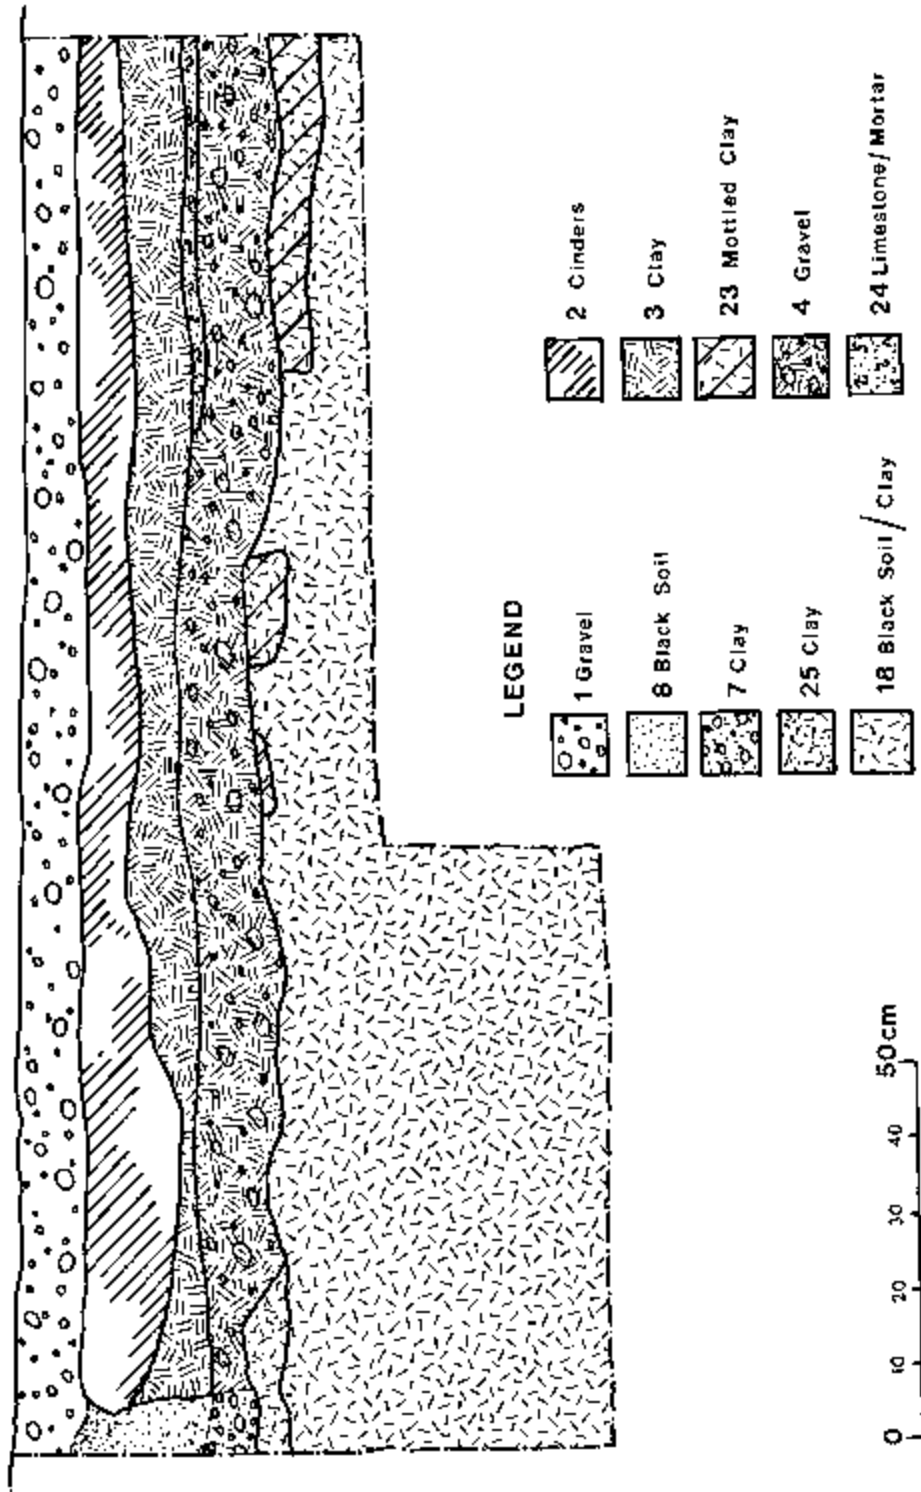
The north profile of the excavation (Fig. 10) shows that the distribution of layer 2 was not as extensive as that of layer 1. Whereas layer 1 extended beyond the limit of excavation, layer 2 stopped at a deposit of black soil (described later as layer 8). The path or road through the gate has thus varied somewhat in width; the gravel extends past the sides of the opening in the gate (Fig. 5) whereas the cinders do not. Since these differences presumably existed while the area was maintained as a park, the change in width of road/path was probably introduced as a matter of appearance rather than any major change in function.

10 North profile of 28 K-1A and 28K-1B (Drafting by K. Walton).

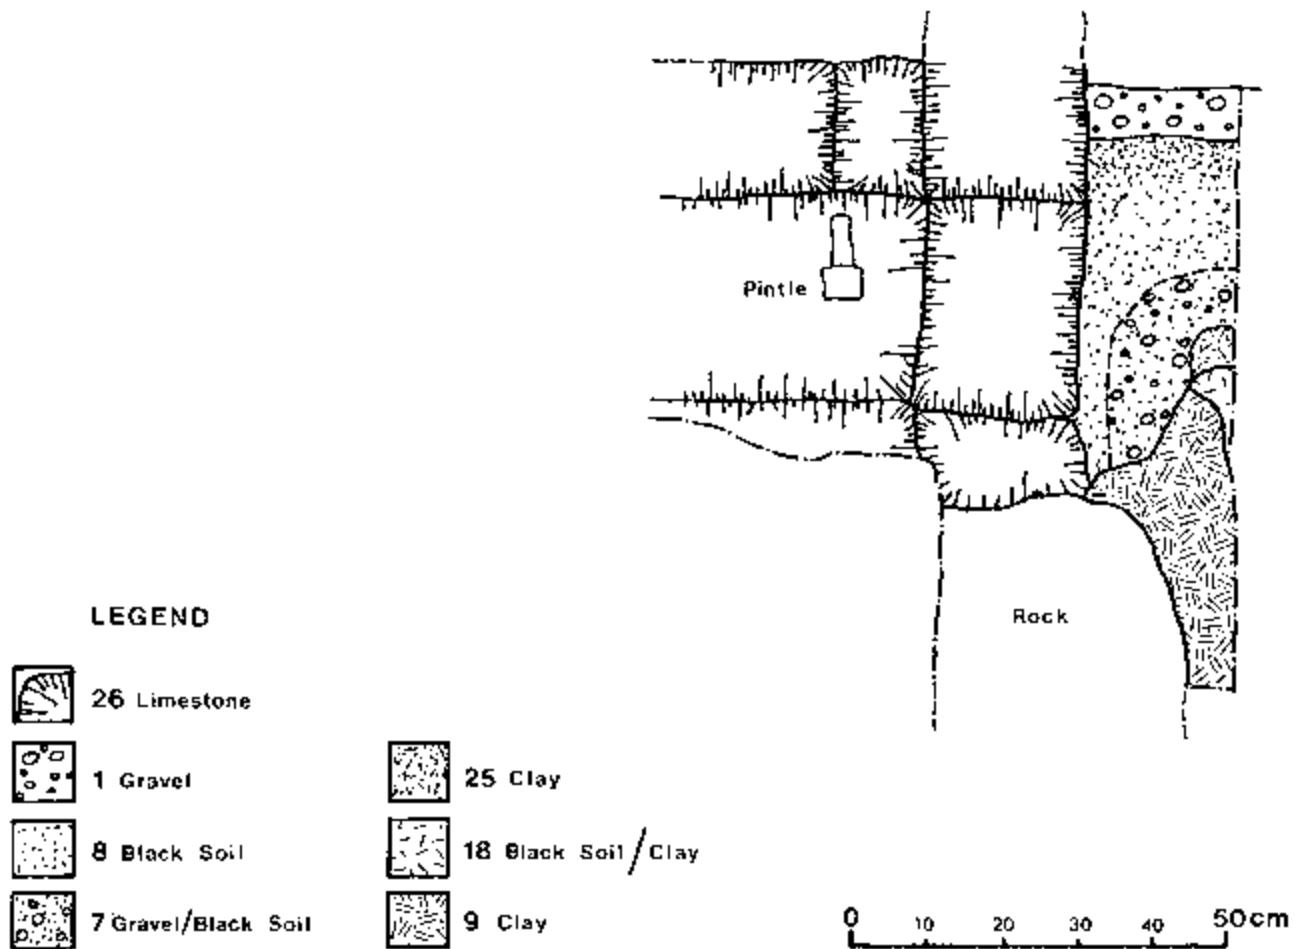
dressed to rough stone is now below the top of layer 18, it is likely that the wall has settled, also causing a slump in layer 9. This slump has been filled and the ground level raised by deposition of a gravelly black soil, layer 7 (Fig. 11), and then black soil, layer 8 (Fig. 11).

As indicated above, the inner surface of the west wall was found to have a pintle set into it in line with two other pintles used to hang the existing gate but now below present ground level (Figs. 5, 11). The three pintles are of the same size and manufacture and are spaced approximately equidistantly. There is no alternative conceivable but that at one time these functioned together for hanging a wooden gate, the bottom pintle being near the bottom of the wooden gate. If, during the occupation period, the roadway was maintained with applications of gravel it is possible that the ground level rose to the extent that it began to interfere with the bottom of the gates. The top of layer 4 (gravel) now is certainly high enough to have interfered with the gate. If the gate was also settling into the ground, there is an even greater chance of the gate operation being hampered by the ground surface.

11 West profile of 28K-1B (Drafting by K. Walton).

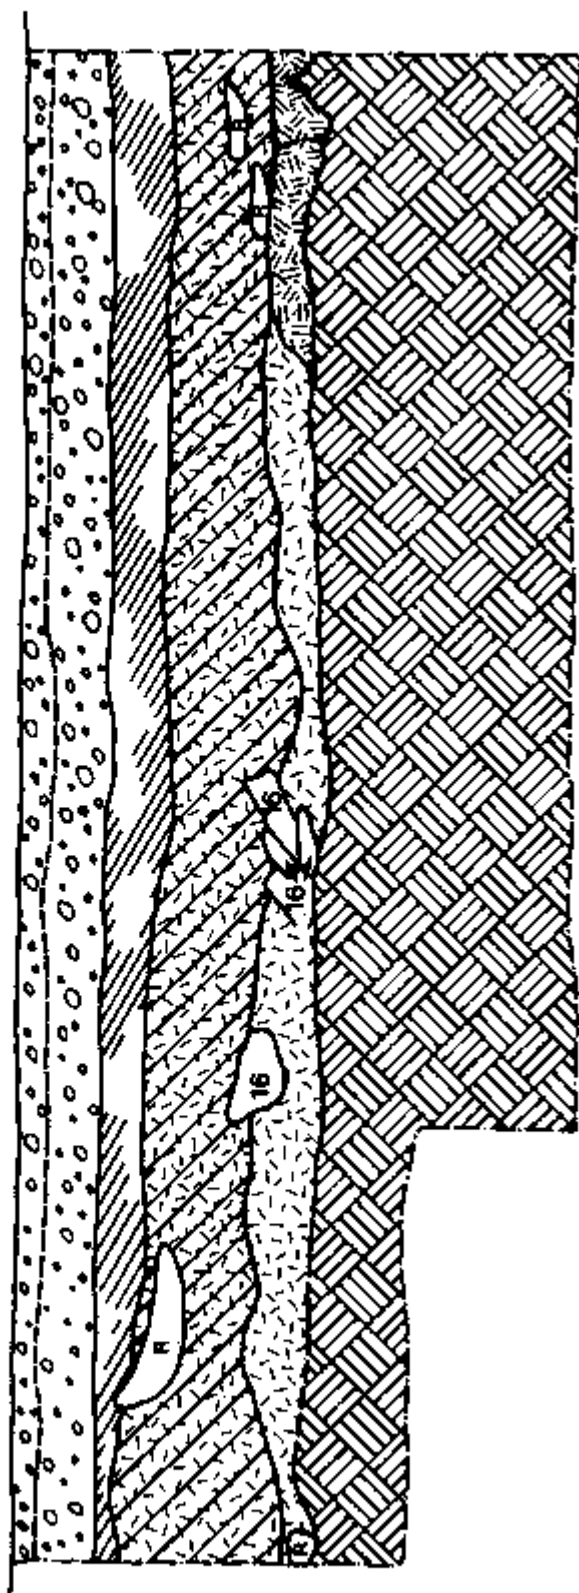
In the southern half of the excavation there was a thin layer of mortared limestone, layer 16 (Figs. 12, 13) partly resting on and in layer 14 and partly on undisturbed soil. In the profile drawing (Fig. 13) layer 16 appears as a scattering of stones.

The stratigraphy in this excavation (Figs. 12, 13) provides a clear indication that layer 3 is a post occupation deposit, after removal of the palisade. However, there are no further indications for its deposition. In general, it would have served to raise and level an area but further excavations will have to be carried out to determine whether the clay is associated primarily with the areas of present paths.

13 28K-2A, west profile (Drafting by K. Walton).

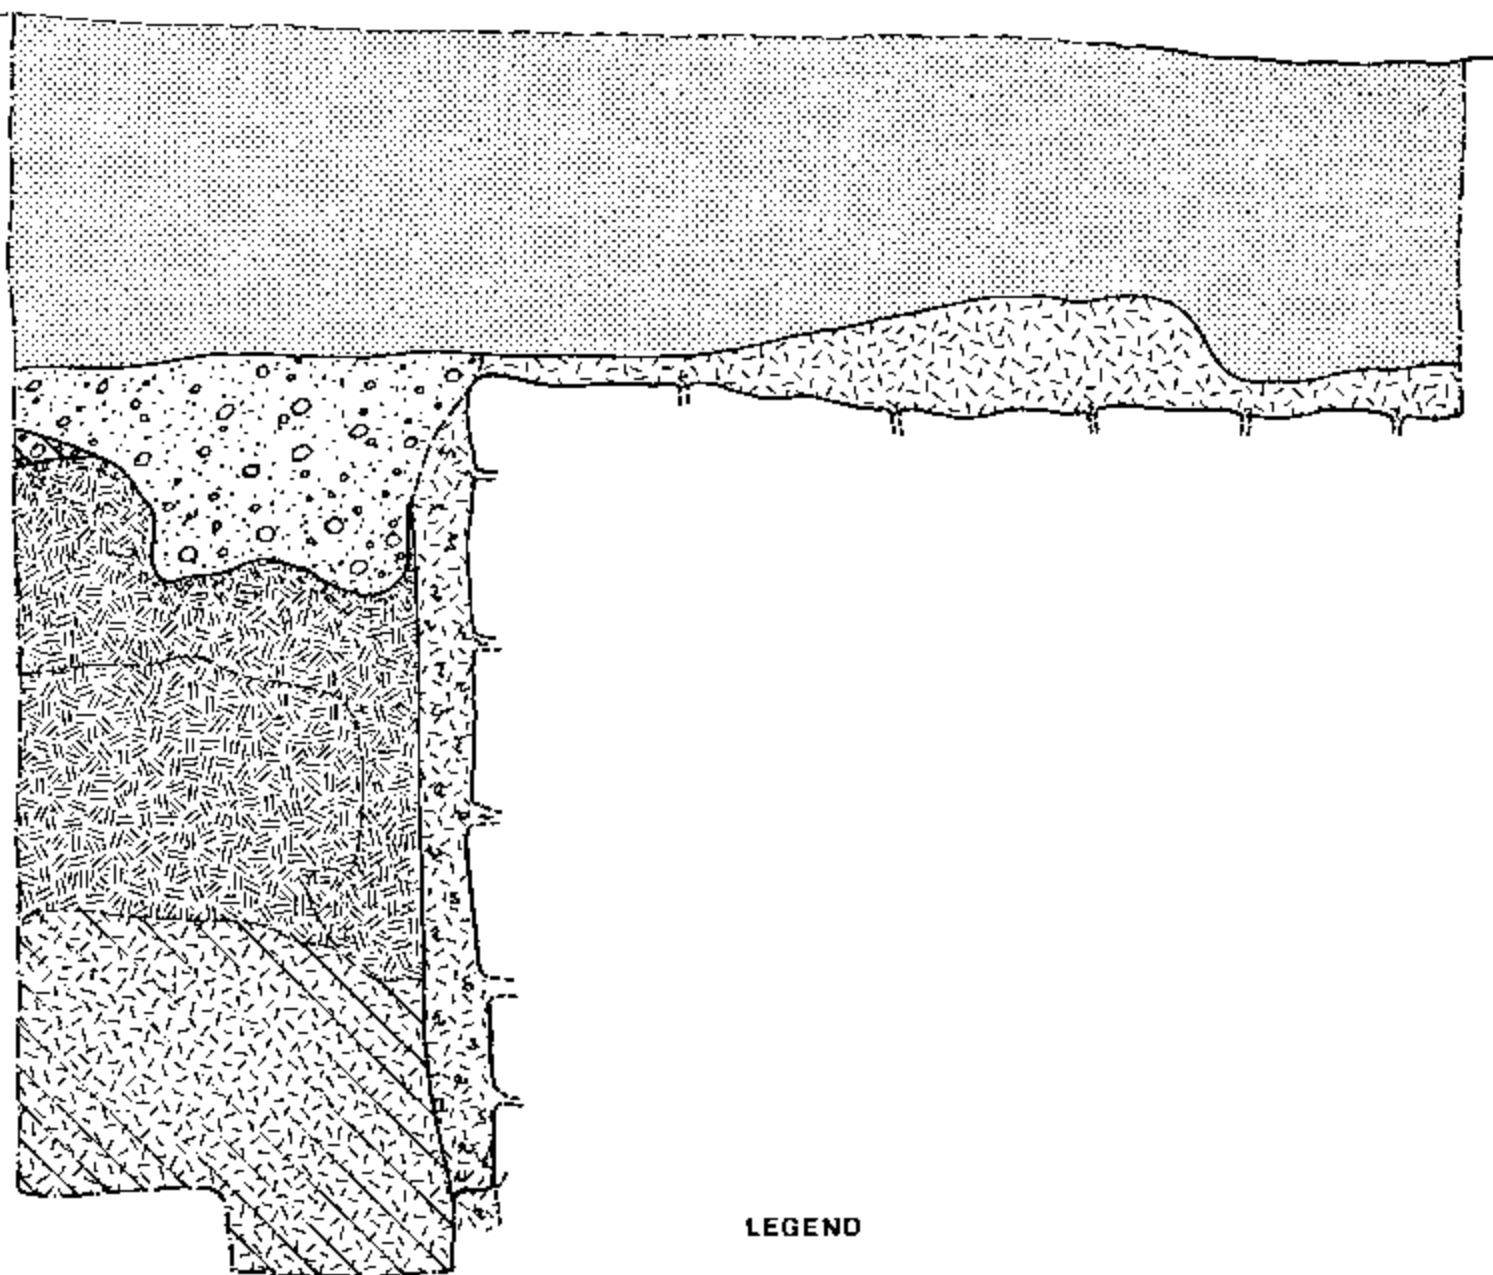
Directly on layer 18 there was a deposit of gravel and limestone chips, layer 11 (Figs. 16, 17), considered to be construction debris. Its location on undisturbed soil strongly suggests an association with construction of the palisade and gate. The presence of a stem fragment from a clay smoking pipe possibly also suggests a 19th century date. This layer probably approximates the ground level during at least part of the occupation period.

Below layer 17 and adjacent to the footing there was a deposit of mixed gravel/black soil filling a depression dug through layer 11 and into layers 18 and 10 (Fig. 16). The relationship of this disturbance to layer 3 is unclear but it probably predates the deposition of any part of layer 17 (Figs. 16, 17). There are no artifacts exclusively associated with this fill.

16 East profile of 28K-2B (Drafting by K. Walton).

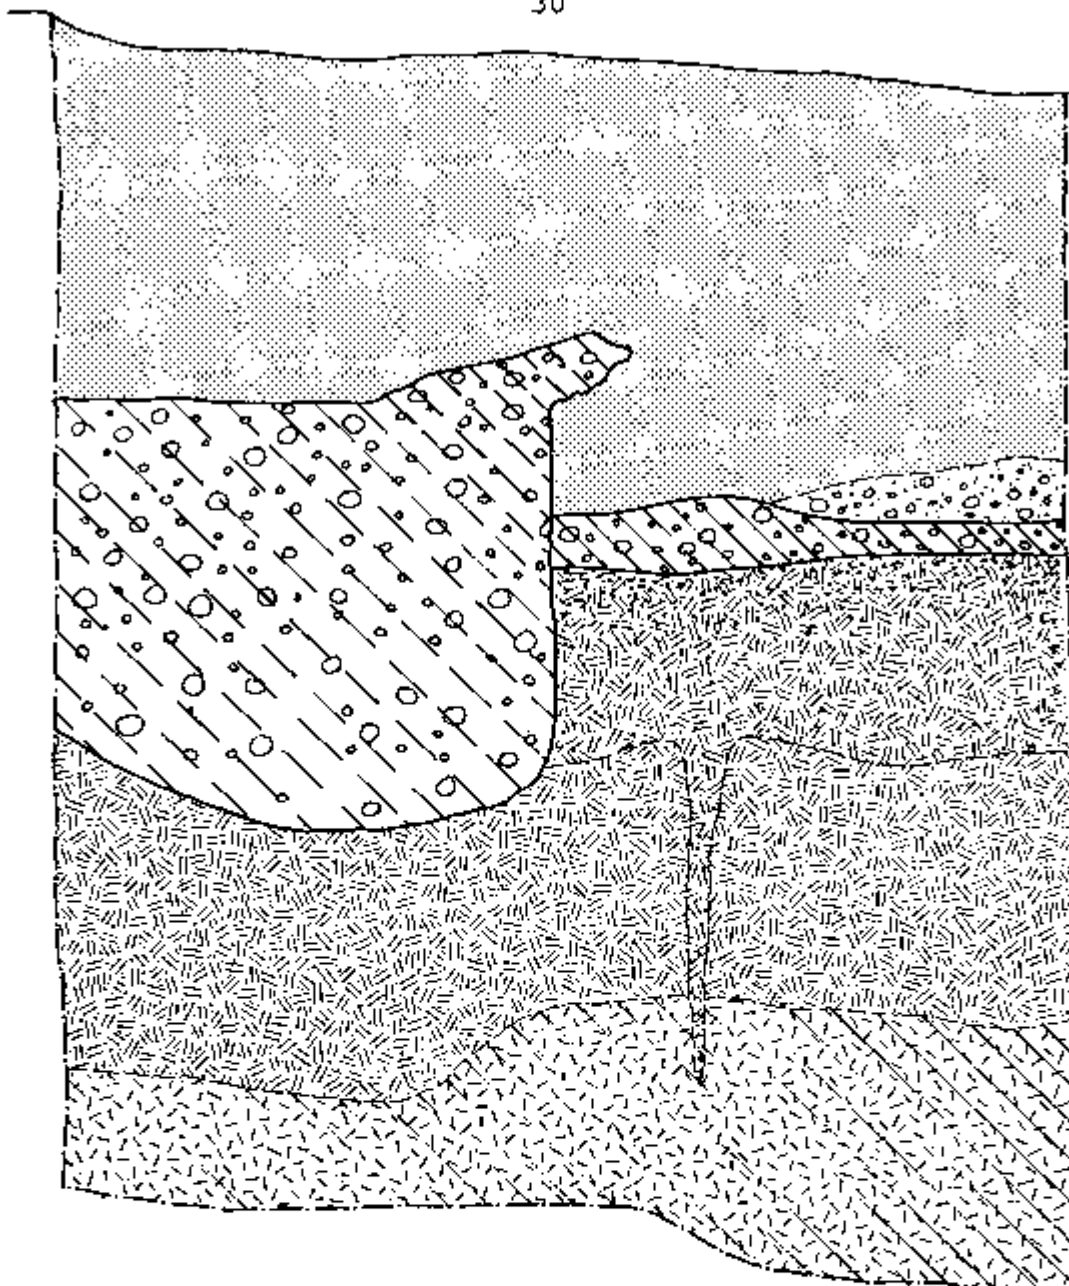
17 North profile of 28K-2B (Drafting by K. Walton).
