# ARCHAEOLOGICAL MONITORING AT THE EARL'S RESTAURANT SITE

T-WEST CANADA LTD.

QUATERNARY CONSULTANTS LIMITED

May, 1994

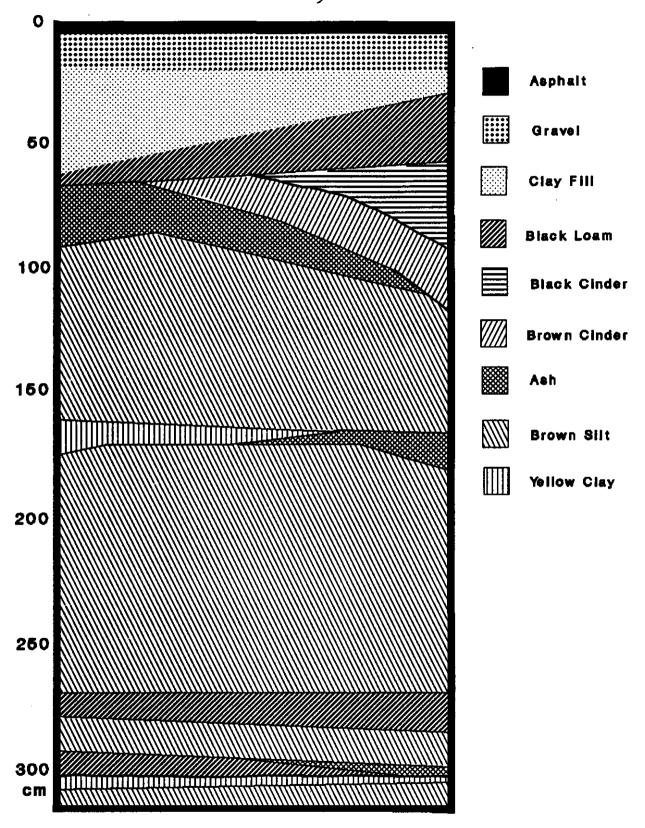
Figure 2: Vertical Profile of Trench 2

The stratigraphy varied slightly between the two sections of the trench. The variations consisted mainly of thickness and slope of the layers. A slightly generalized profile, relying on average depths and thickness of the recorded strata is presented in Figure 2.

Artifacts were recovered from three discrete layers: the loam/cinder/ash complex at 70 to 100 cm; the yellow clay/ash component at 170 cm; and the loam/ash component at 300 cm (Plate 3). Most of the recoveries derived from the highest layer, although stratigraphic sequence does not appear to indicate age of deposition. One of the Drewry bottles, dated 1902, came from the bottom horizon and the other bottle, dated 1901, derived from the top horizon. Very few artifacts were recovered from the middle horizon, the most notable being the axle spindle.

The stratigraphic sequence seems to indicate continual land modification activities. The relatively thick loam horizon at 270 cm could indicate the land surface during the 1880s, in which case the brown silt layer immediately below could represent sediment deposition by the 1882 flood. If this is the case, the loam/ash horizon at 300 cm would represent original ground surface in the 1870s, when the first urban activity began on the site. This loam/ash horizon would be resting upon sediments deposited by either, or both, of the 1861 or 1852 floods.

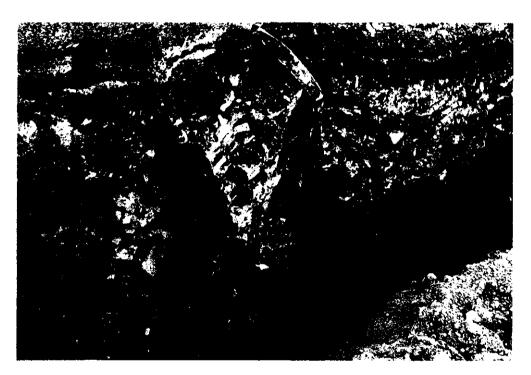
Plate 5: Structural Debris in Trench 4

Trench 4: The trench was oriented northeast/southwest and extended approximately six meters in length. A concrete floor was encountered at a depth of 240 cm.

The entire excavation area was filled with building rubble: fieldstone, brick, and concrete (Plate 5). A fieldstone foundation wall, topped with courses of brick was present at the south end of the trench (Plate 6). A concrete wall was encountered six meters to the north. Both walls were oriented east/west and sat upon a concrete floor. Service installation required the removal of the floor which rested upon blackish clay fill. No artifacts were curated from this location.

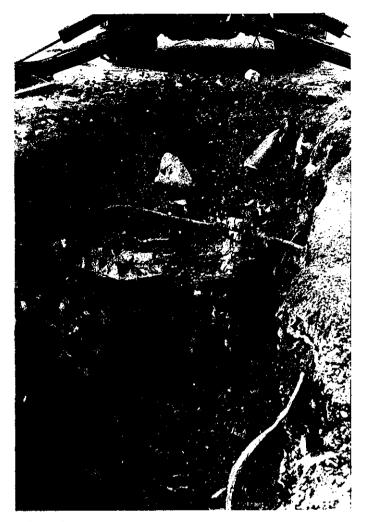
Plate 6: Basement Wall at South End of Trench 4

The stratigraphy represents relatively recent activities. The upper 80 cm consisted of a repetitious sequence of asphalt, gravel, black clay fill, asphalt, and gravel. These strata overlay a thick (80 to 115 cm) layer of red-orange sand (or finely crushed brick) which contained a small quantity of artifacts. Below the sand, a layer of black clay fill which contained structural residue (brick, wood, and windowpane) continued to the base of excavations. A concrete basement footing wall was encountered at the southwest end of the trench.

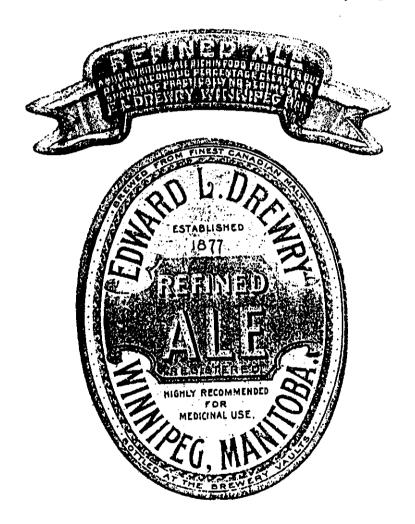
Figure 4: Drewry 'Refined Ale' Label (Chopping 1978:113)

The number "02" on the base indicates the year this bottle was manufactured, 1902. Chopping (1978:117) has this type listed as MWIN BG9-1. The incomplete paper label has elements which are very similar to those portrayed in the label on MWIN BG1 (Chopping 1978:113) as well as a label portrayed in an advertisement in the 1903 Henderson Directory (Figure 4).

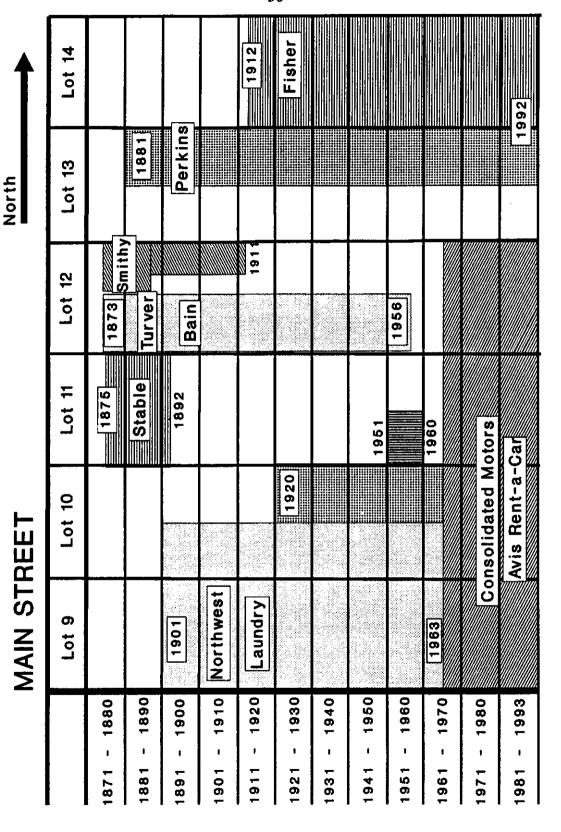
Figure 6: Structural History of the Site

The occupation history of the site (Lots 9 to 14) during the urban period has been comprehensively detailed by National Testing Laboratories Limited (1993). Their report is the primary reference for the following synthesis. Additional data has been obtained from City of Winnipeg Henderson Directories for the years 1880 to 1925. Several of the structures existed for considerable time (Figure 6), even if the companies or individuals occupying them tended to change with a rapid frequency. For ease of reading, repetitious citations of the two sources will not be included, however, the data can be attributed to either source. It must be cautioned that addresses for locations or businesses listed in the Henderson Directories are not always consistent. In extreme cases, a location will have different addresses in successive years, some of which will indicate renumbering of the location by City Authorities while others represent recording or typographical errors. It must also be noted that information in the Directories does not always correspond with maps produced the same year. The maps depicted by National (1993:Appendix E) and Main Street panoramas (National 1993:Appendix D) have been reproduced in this report as Appendix B.
