MEMORANDUM NO TE DE SERVICE

Subject:
Objet: Excavation of Flagpole Base at The Forks NHS

8:28 Am. - Flagpole base - Farker DHS

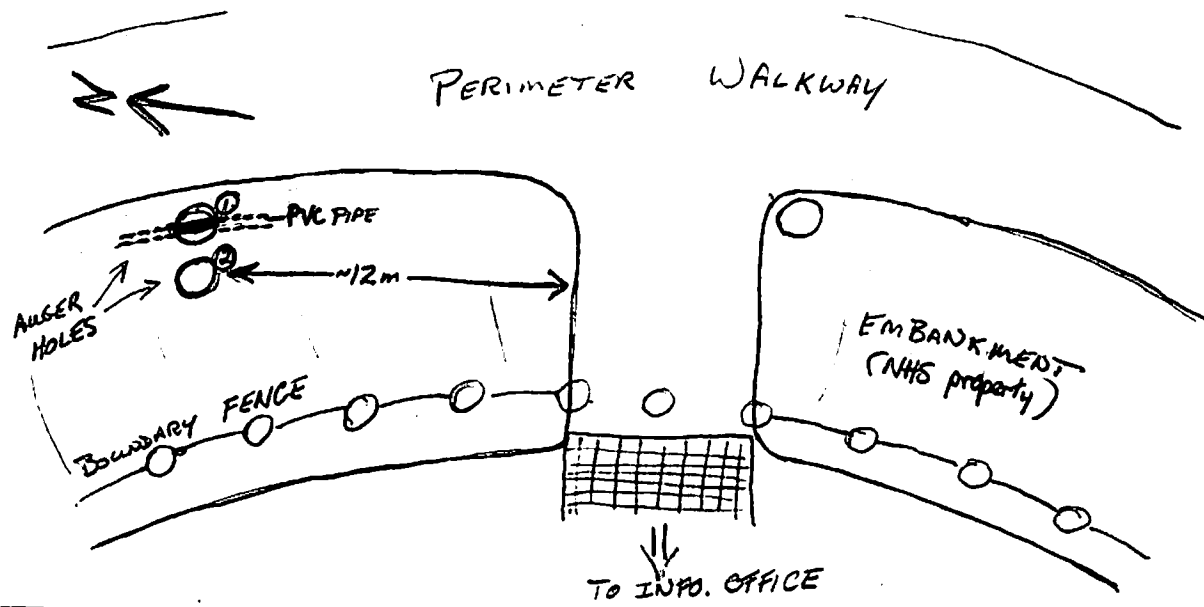
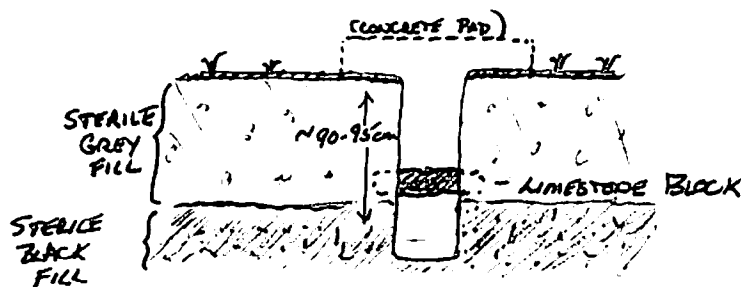
② Auger went down ~ ⁶⁵50 cm - hit solid rock/concrete surface;
(~18 inches) (brick rubble?) -
attached w. jackhammer - broken rock frags came up (limestone);
continued augering; hit black fill; quit ~ 80 cm.

Paul and I left the crew in process of preparing to mix and pour the concrete. This was about 9:20 AM. Our conclusion is that excavations penetrated clean fill only, and did not extend into deposits that predate construction phase of the National Historic Site.
