MANITOBA ARCHAEOLOGICAL JOURNAL

STRUCTURAL EVIDENCE OF UPPER FORT GARRY

Sid Kroker
Quaternary Consultants Limited

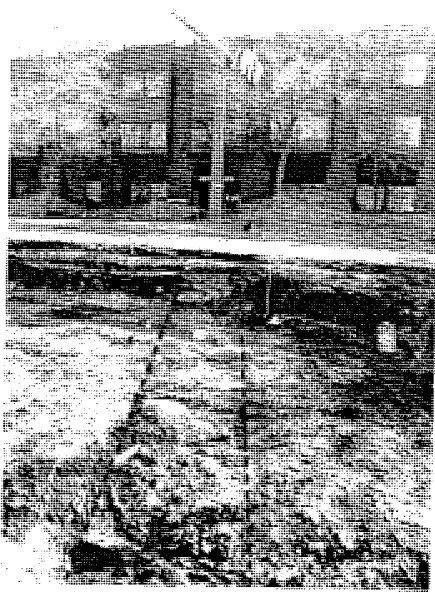
Figure 2: Footing of the 1836 north wall.

The excavations on the west side of Main Street encountered the footings of the original north wall of Upper Fort Garry. This feature extended across the west half of the street, from the sidewalk to the median curb (Figure 1:2). The centre line of the feature was surveyed, using the City of Winnipeg benchmark at the north end of the Bridge of the Old Forts, south of the intersection of Main Street and Assiniboine Avenue. The centre of the trench, at the sidewalk, lies 50.3m north of the north curb of Assiniboine Avenue.

This sub-surface component of the original wall, built in 1836, consisted of the outline of a trench 122.0cm wide. The portion of the trench remaining below the prior impact zone contained rounded river boulders (up to 50.0cm diameter) and irregular limestone cobbles (Fig. 2). The spaces between the rock material had been infilled with sand and clay. A soil profile was recorded at the west curb, immediately north of the trench. A second profile was recorded at the median curb, 60.0cm south of the trench (Table 1).

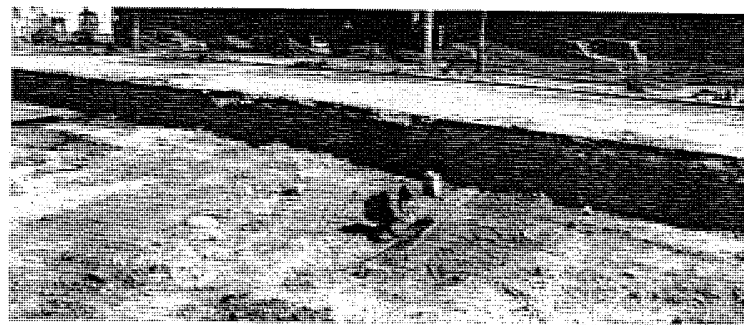
Figure 3: Wooden fence.

The remnants of a linear wooden structure are located 7' south of the original 1836 north wall (Figure 1:3). The structure consists of parallel rows of sawn boards with remnants of vertical posts between them (Fig. 3). This component continues from the west sidewalk to the median divider. The feature is composed of paired 1.5"x6" boards spaced with vertical 4"x4" posts, averaging six feet apart. Original speculation during exposure was that this feature could represent a support structure for a catwalk along the north wall. Loewen and Monks (1986:56) note that

Sections of two different boards (DILg-21:96A/2 and 736) were submitted for dendrochronological analysis. The examination determined that they derived from the same tree,

having slightly different thicknesses (DILg-21:96A/2 = 3.5cm, DILg-21:96A/736 = 3.2cm) which would indicate individual hand manufacture rather than mechanical production. As neither sample possessed bark, the determined ages can only be considered as minimum dates. DILg-21:96A/2 yielded a minimum date of 1850 while DILg-21:96A/736 has a minimum date of 1839. Both boards derive from a tree cut after 1850 (Nielsen 1998:215). This rapidly eliminates the possibility of the timber being part of the catwalk (gallery) support structure, as it was built during the first phase of the fort (ca.1835-1837). Based on Beatty's map, the interior fence of the military period was in place by September 1846. Again, the documented construction pre-dates the wood. Also, Beatty's map places the fence 11'7" south of the north wall, while Loewen and Monks' reconstruction plan of the fort, as it would have been in 1850, places the military fence at 15'5" south of the wall (Loewen and Monks 1986:59).

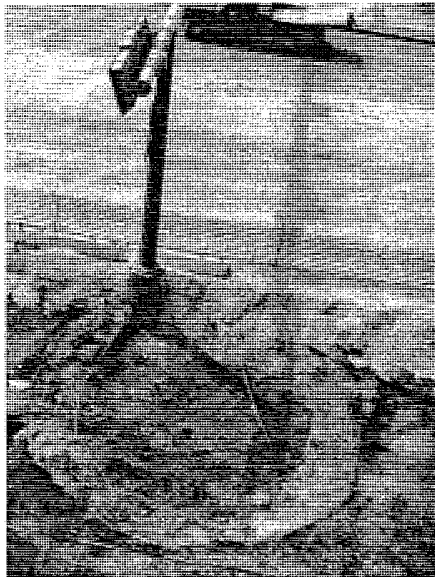
Figure 4: Northeast bastion with internal wood feature (marked by flagging tape).

The bastion (Fig. 4) was placed such that the centre lines of the north wall and the east wall passed through the interior of the bastion. The actual alignments were such that the continuations of the outer edges of the walls intersected at the centre of the bastion. The walls joined to the curve of the bastion (Fig. 1:4). The entranceway into the bastion was in the corner of the fort, with arcs of the bastion protruding into the interior of the fort. However, the sub-surface footing of the bastion is a complete circle of semi-dressed blocks of limestone (Fig. 5).

During the excavations, a wooden component was uncovered in the centre of the northeast bastion (Fig. 4). A three-sided rectangle of squared wooden timber, measuring 9'6" (2.90m) by 8' (2.45m), was situated with the open side oriented toward the east wall (Fig. 5). The wood, severely decomposed, was left *in situ*. The timbers measured 7.0cm (2¾") wide—obviously insufficient for a support structure for the second floor. Also, no vertical timbers were present. It is more likely that this component represents a framework for a set of stairs for access to the upper level.

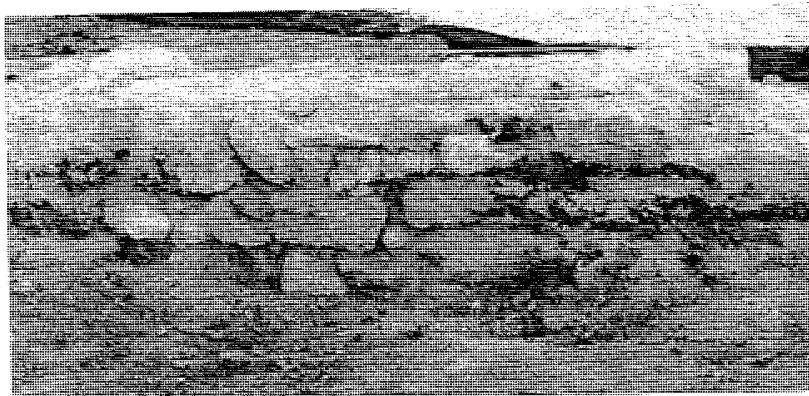
Figure 6: Coursed limestone construction of north portion of east wall.

The east wall is situated at a 90° angle to the north wall and abuts the outer side of the northeast bastion (Fig. 1:5). The northern end of the east wall footing consists of several layers of dressed limestone blocks, laid in courses (Fig. 6). This stone component extends 19'6" (5.35m) southward. At this point, the stonework ceases and the outline of the trench is present, but infilled with a light brown clayey silt. The silt trench filling extends southward and gradually disappears about 30' (9.5m) from the end of the stonework. From this point southward, no trace of any trench outline is present. It would appear that no sub-surface preparation for the east wall was undertaken for most of the length of the wall.

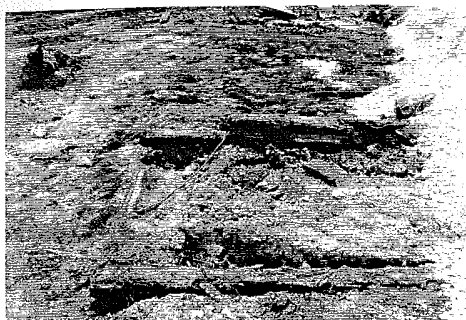
Figure 7: Northeast crib feature.

This feature (Fig. 1:6) consists of a rectangular outline of interlocked logs. The external measurement of the north side (oriented parallel to the north wall of the fort) is 8'6" (260.0cm) and that of the east side is 5'8" (173.0cm). The east side of the feature is parallel to the east wall of the fort, located 6'6" (210.0cm) west of the inner side of the wall. The feature is only one course of logs above the base of excavations and is filled with a grey sandy gravel (Fig. 7). The north side of the feature, adjacent to the northeast corner, consists of a black soil which contained faunal material and

The sandy gravel layer extends upward to the base of the previous road bed, while there are no additional logs above those observed *in situ*. The position of the gravel suggests that an intrusive activity (which was later infilled) occurred at this location, thereby resulting in the presence of the gravel on top of a fur trade period structure. This structure could have been a privy, a cribbed waste pit, or a root cellar.

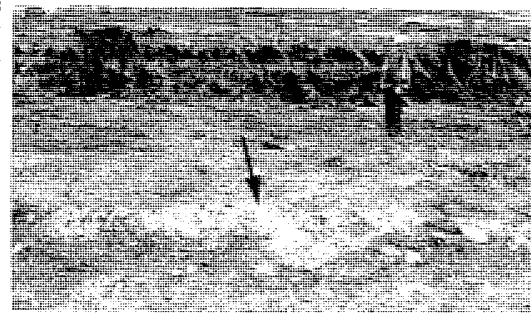
Figure 8: Northwest corner of footing on Men's House.

The footings of a structure (Fig. 8) were uncovered 40'4" (12.3m) south of the north wall (Fig. 1:7). The external sides of the rectangular footprint measure 42'2" x 24'9" (12.85m x 7.5m). This conforms with the recorded dimensions of the men's house of 42' x 24' (Loewen and Monks 1986:208), as it is expected that the footing would be slightly larger than the actual structure. The north and south walls are 2'5" (75.0cm) thick and the east and west walls are 2'2" (65.0cm) thick. The footings are composed of limestone spalls with some sand, ash, and silt filling the interstitial spaces.

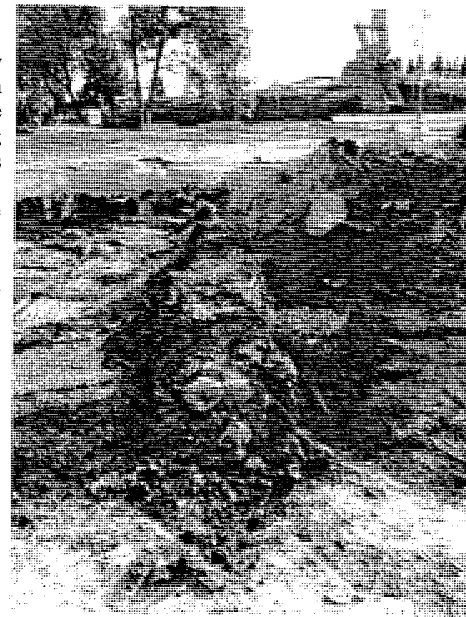
Figure 9: South wall.

The footing of the south wall was exposed near the southern end of the excavations on Main Street (Fig. 1:12). It is situated 26'2" south of the south wall of Feature 11. The construction of the wall footing was similar to that of the northern portion of the East Wall — several series of roughly dressed limestone blocks producing a linear wall approximately 3'4" (102cm) wide (Fig. 9). The continuity of the wall was breached by the MTS ductline at the western edge of the construction area and was also missing at the eastern edge of the construction excavation.

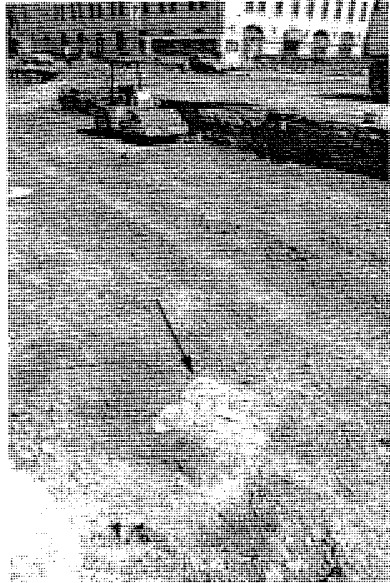
Figure 10: Limestone slab pad for uprights of 1852 northeast wall.

The size of the fort was nearly doubled in 1852-53 with the construction of a three-sided walled rectangle adjoining the north side of the existing fort perimeter (Loewen and Monks 1986:102-104). The new eastern wall (Fig. 1:13) continued north from the northeast bastion, in alignment with the existing stone east wall. This "new wall was only ten feet (3.05m) high and consisted of a hollow wooden structure three feet (0.91m) in width, secured upon a stone foundation and braced inside with 14 inch (0.36m) oaken planks running horizontally and a rammed earth core" (Loewen and Monks 1986:102). The vertical uprights appear to have rested on tabular limestone slabs (Fig. 10) which were spaced approximately 11'6" (3.5m) apart. The slabs occurred at the base of the roadbed excavation and had no other material above them. It would appear that the vertical uprights would have been pulled when the wall was demolished. The surviving remnant of this type of construction is at the extant North Gate west of Main Street.
